Test Report No: TJ3568 Rev 1

SUBJECT: Wall assemblies evaluated in accordance with Technical Guide for Intumescent Coating as a Thermal Barrier over Spay Urethane Insulation (Master Format 09 96 48) Appendix F

PRODUCT EVALUATED: Client refers to samples received as "SWD Quick-Shield 112 F, 2lb closed cell spray applied polyurethane foam (CCMC #13555-L) with 18 mil wft of International Fireproof Technology DC315" and "SWD Quick-Shield 112 F, 2lb closed cell spray applied polyurethane foam (CCMC #13555-L) with 3 mil primer and 24 wft of International Fireproof Technology DC315". This project was entered into our receiving system on 02/01/16 in good condition.

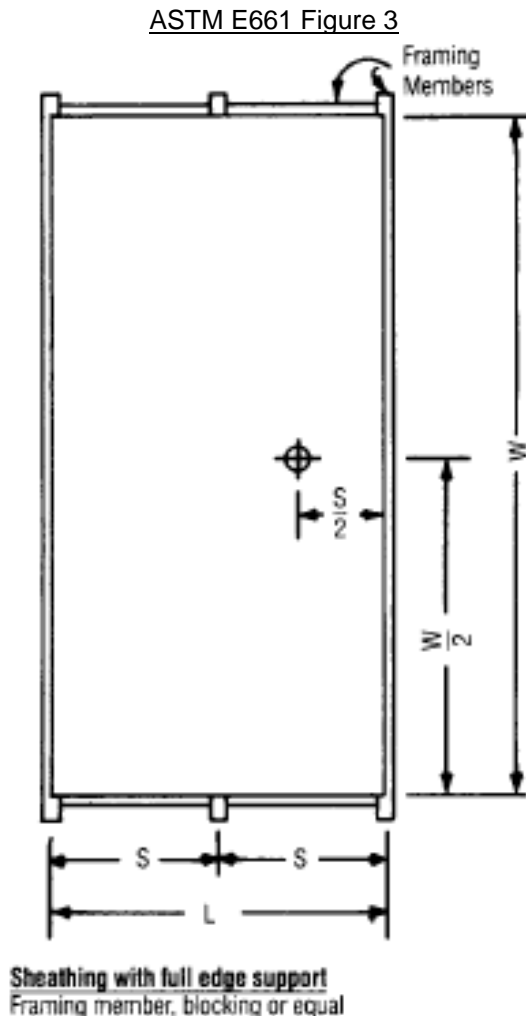
Note: The below assembly configuration was utilized in all the testing outlined in this test report. Premium grade 2X4's were utilized in the frame construction of the 4 foot by 8 foot assemblies and a stud placed 24 inches on center as shown in the figure below:

Four assemblies were constructed. The first assembly was covered with Gerogia-Pacific ToughRock 3/8 inch gypsum board and fastened to the assembly every 12 inches with Grip-Rite #8 black phosphate drywall screws. The second assembly was covered with Gerogia-Pacific ToughRock 1/2 inch gypsum board and fastened to the assembly every 12 inches with Grip-Rite #8 black phosphate drywall screws. The third assembly was covered with Gerogia-Pacific ToughRock 1/2 inch gypsum board, fastened to the assembly every 12 inches with Grip-Rite #8 black phosphate drywall screws, the drywall was sprayed with approximately 3-1/2 inches of SWD Quick-Shield 112 F spray applied foam, and the foam was coated with 18 mil (wft) of DC315. The fourth assembly was covered with Gerogia-Pacific ToughRock 1/2 inch gypsum board, fastened to the assembly every 12 inches with Grip-Rite #8 black phosphate drywall screws, the drywall was sprayed with approximately 3-1/2 inches of SWD Quick-Shield 112 F spray applied foam, and the foam was coated with 3 mil (wft) primer and 24 mil (wft) of DC315.

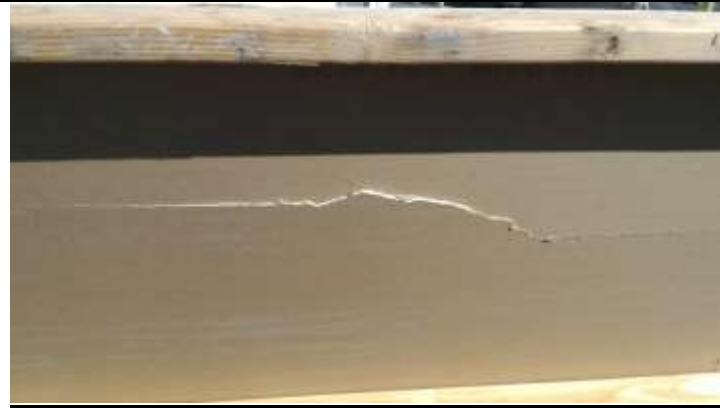
<p><u>Assembly (1): 3/8 inch gypsum covering Failure @ 6" Impact</u> <u>Backside of Gypsum Board</u></p>

Assembly (1): 3/8 inch gypsum covering				
Test Results	Sample 1	Sample 2	Sample 3	Average
Ultimate Impact Height Observed	< 6 inches	< 6 inches	< 6 inches	< 6 inches
Impact Failure Point	NA	NA	NA	-
Proof Load	NA	NA	NA	-
Deflection @ Proof Load	NA	NA	NA	-

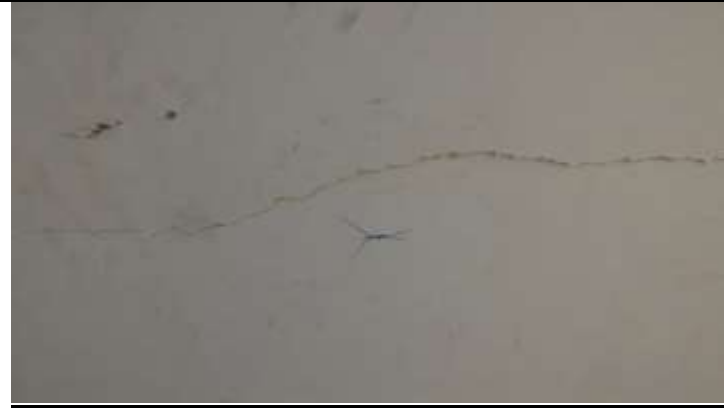
<p><u>Assembly (1): 3/8 inch gypsum covering Failure @ 6" Impact</u> <u>Frontside of Gypsum Board</u></p>

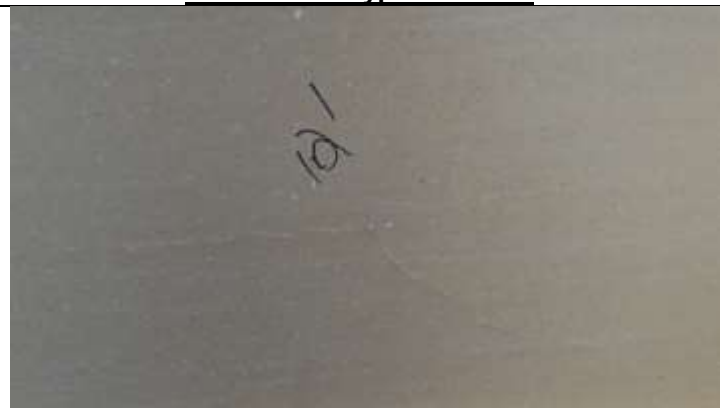
<p><u>Assembly (2): 1/2 inch gypsum covering Failure @ 12" Impact</u> <u>Backside of Gypsum Board</u></p>

Assembly (2): 1/2 inch gypsum covering				
Test Results	Sample 1	Sample 2	Sample 3	Average
Ultimate Impact Height Observed	6 inches	6 inches	6 inches	6 inches
Impact Failure Point	12 inches	12 inches	12 inches	-
Proof Load @ 6" Impact, lbs	92	92	92	92
Deflection @ Proof Load	0.0489	0.0514	0.0503	0.0502

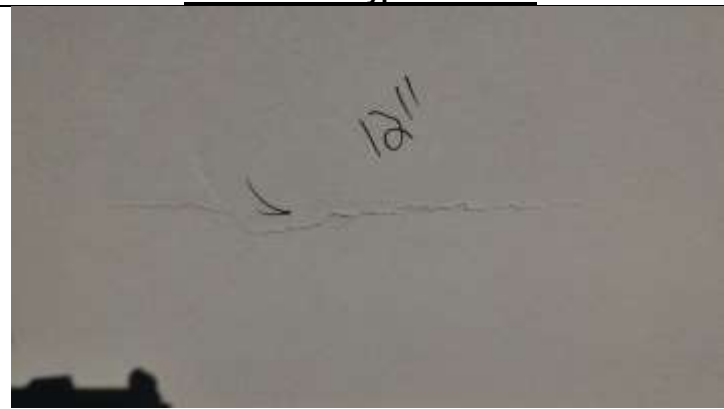
<p><u>Assembly (1): 1/2 inch gypsum covering Failure @ 12" Impact</u> <u>Frontside of Gypsum Board</u></p>

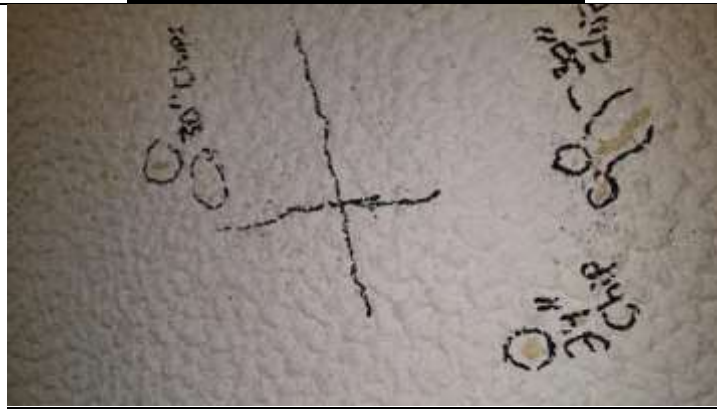
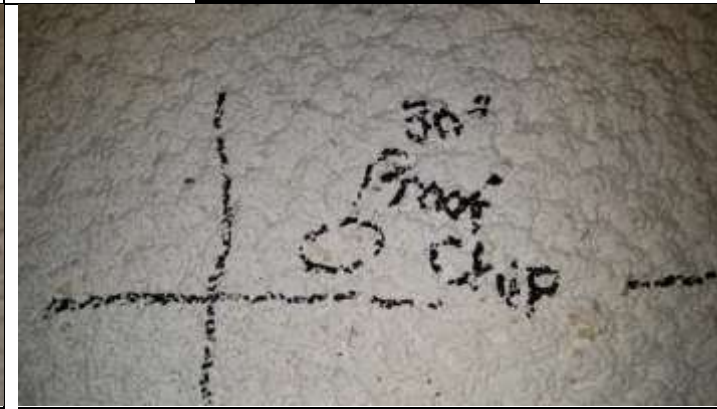
<p><u>Assembly (3): 18 mil (wft) of DC315 Coating Delamination @ 24" and 30" Impact</u></p>	<p><u>Assembly (3): 18 mil (wft) of DC315 Coating Delamination @ 30" Impact</u></p>

Assembly (3): SWD Quick-Shield 112 F spray applied foam and the foam was coated with 18 mil (wft) of DC315				
Test Results	Sample 1	Sample 2	Sample 3	Average
Ultimate Impact Height Observed	18 inches	18 inches*	18 inches*	18 inches*
Impact Failure Point	>30 inches*	>30 inches*	>30inches*	-
Load ¹ @ 18" Impact, lbs	183	183	183	183-
Deflection @ Proof Load	0.0580	0.0390	0.0480	0.0483

*small chips less than 1/2" in diameter of coating delaminated from the foam substrate was observed after the 18" drop height.

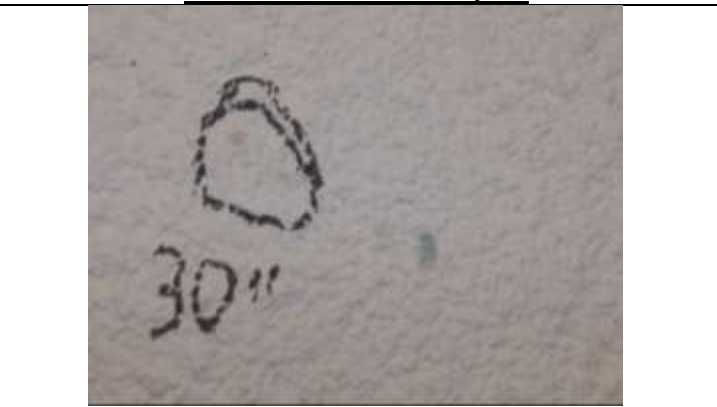
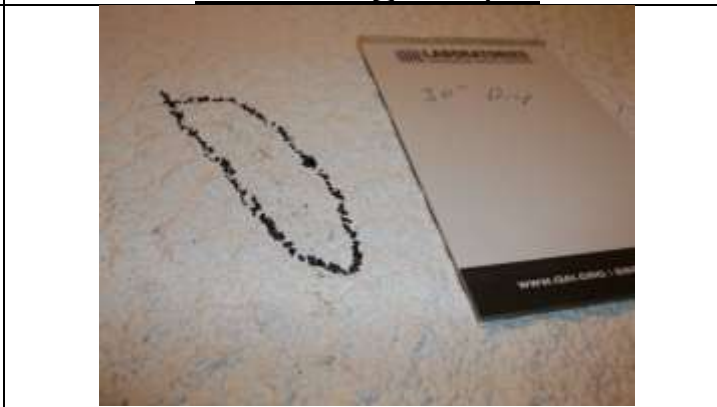
<p><u>Assembly (4): 3 mil (wft) primer and 24 mil (wft) of DC315 Delamination @ 30" Impact</u></p>	<p><u>Assembly (4): 3 mil (wft) primer and 24 mil (wft) of DC315 Delamination @ 30" Impact</u></p>

Assembly (4): SWD Quick-Shield 112 F spray applied foam, and the foam was coated with 3 mil (wft) primer and 24 mil (wft) of DC315				
Test Results	Sample 1	Sample 2	Sample 3	Average
Ultimate Impact Height Observed	24 inches	24 inches*	24 inches*	24 inches*
Impact Failure Point	>30 inches*	>30 inches*	>30inches*	-
Load ¹ @ 24 Impact", lbs	183	183	183	183-
Deflection @ Proof Load	0.0623	0.0419	0.0536	0.0526

*small chips less than 3/16" in diameter of coating delaminated from the foam substrate was observed after the 18" drop height.

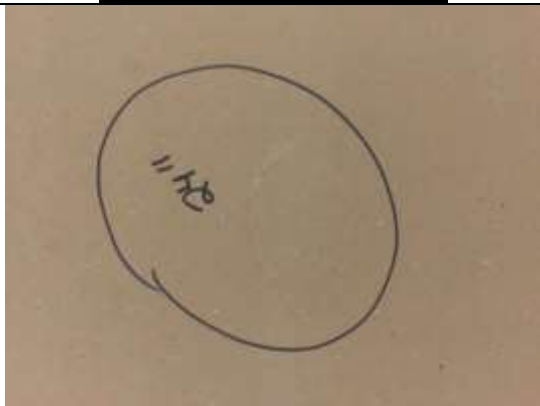
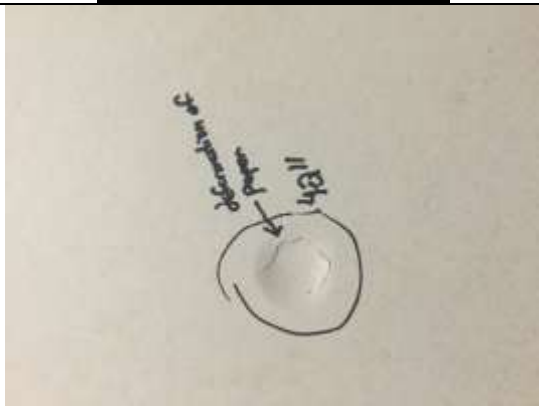
<p><u>Assembly (1): 1/2 inch gypsum covering Failure @ 24" Impact</u> <u>Backside of Gypsum Board</u></p>	<p><u>Assembly (1): 1/2 inch gypsum covering Failure @ 42" Impact</u> <u>Frontside of Gypsum Board</u></p>

Assembly (2): 1/2 inch gypsum covering				
Test Results	Sample 1	Sample 2	Sample 3	Average
Impact Failure Point (Front)	42 inches	42 inches	42 inches	42 inches
Impact Failure Point (Back)	24 inches	24 inches	24 inches	24 inches
Impact Failure Point (Complete Penetration)	78 inches	78 inches	72 inches	78 inches

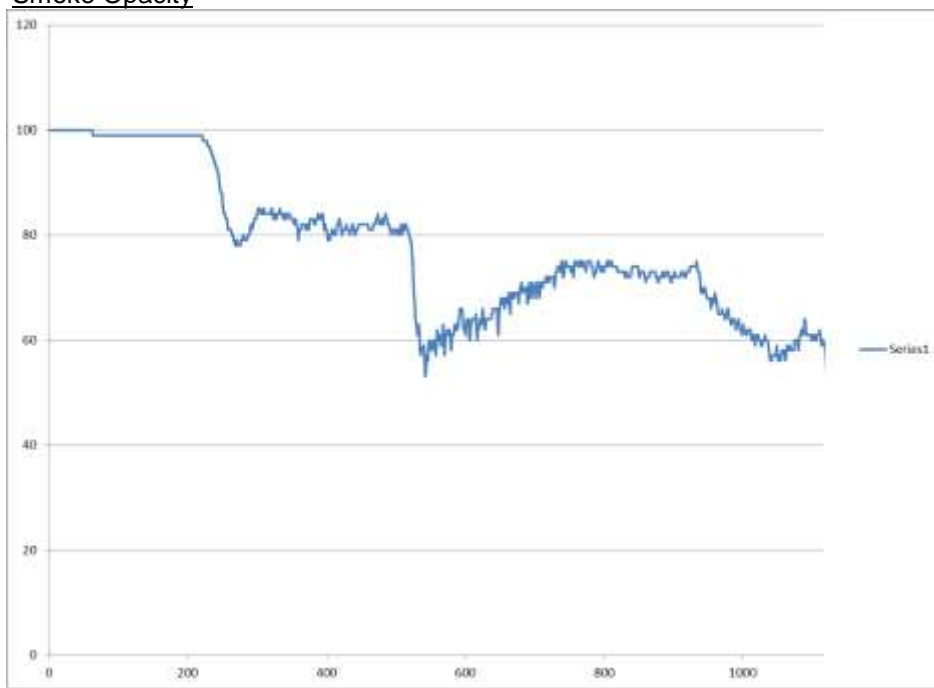
Charts: Smoke Opacity

Flame Spread Observation: Flame spread of the sample was minimal. Almost no visible contribution from the test sample was noted around flames from burner for the first 5 minutes of test. From that point forward there was no significant contribution of material to the intensity of flaming. Flames did not reach the extremities of the test module.

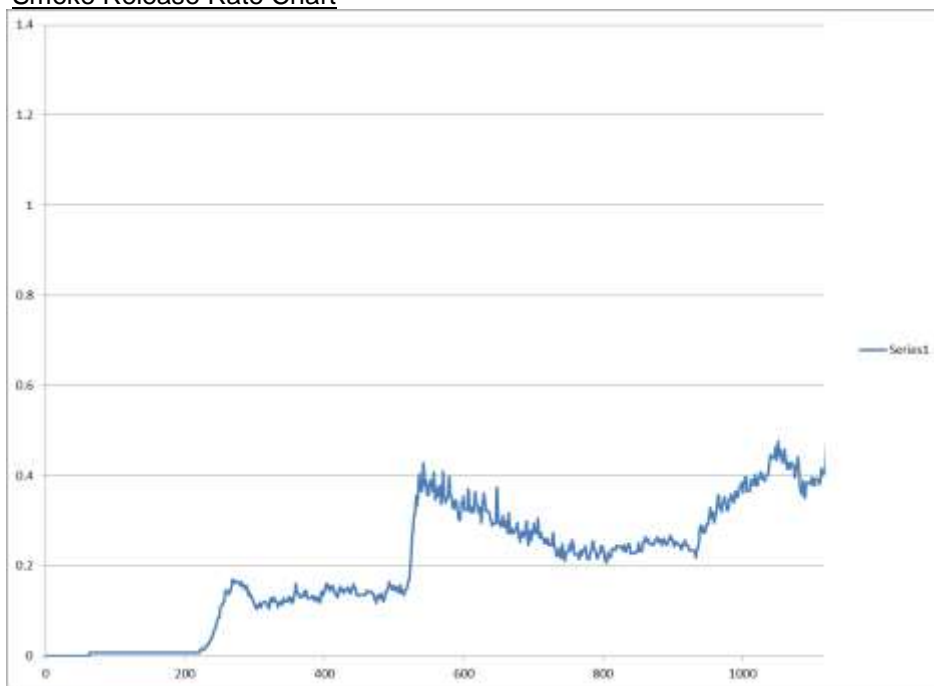
Smoke Release Rate Chart

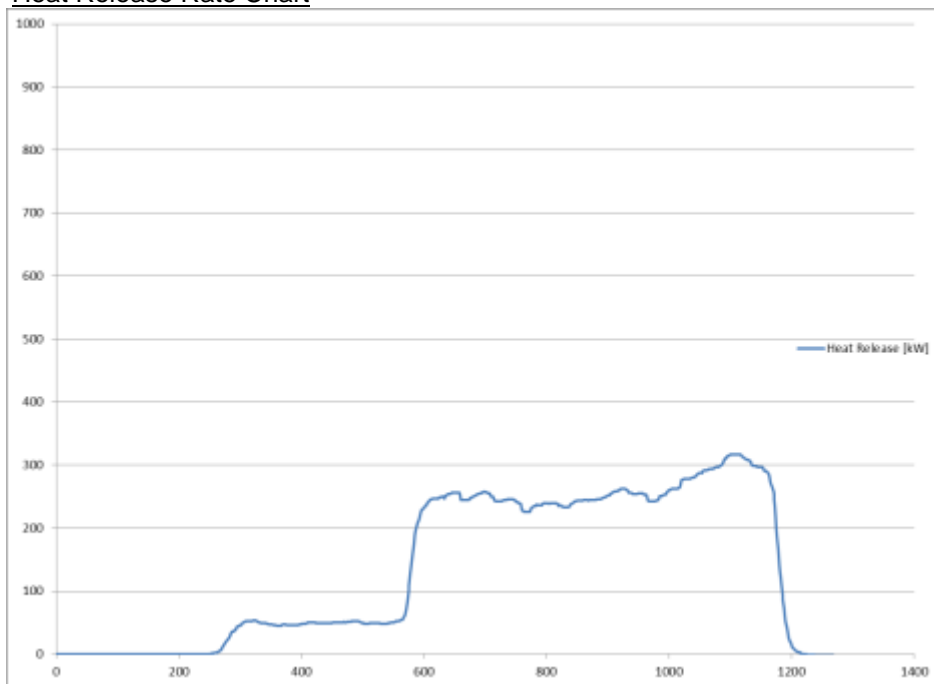
Heat Release Rate Chart

Peak Heat Release: The heat release measured was 317 kW at 14 minutes 1 second into test.

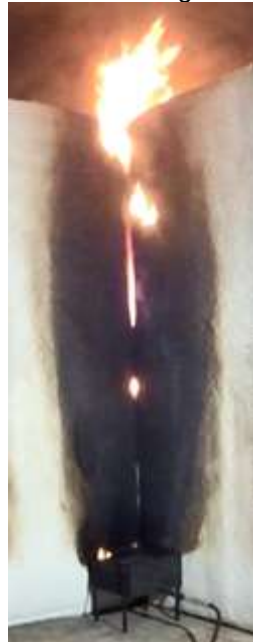
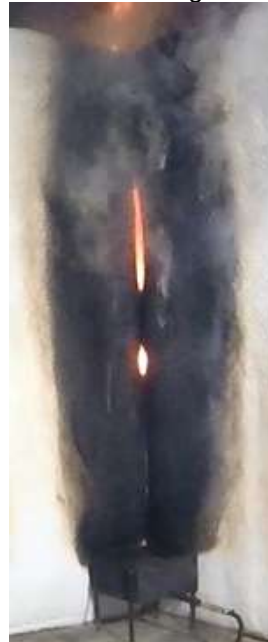
Wood Frame Ignition

- 0:08:00 – Little change in conditions above to coating and foam, wood framing at the top of the assembly has ignited
- 0:10:00 – Little change in conditions above

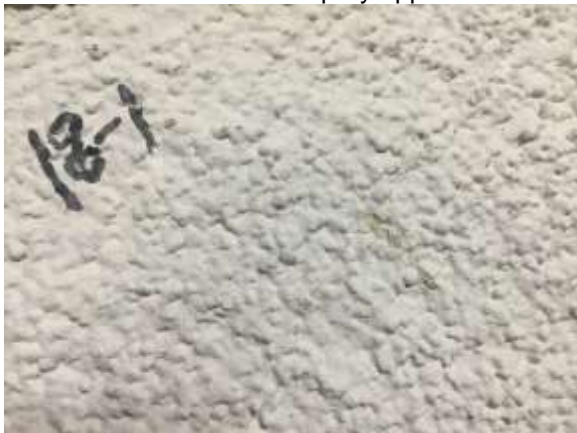
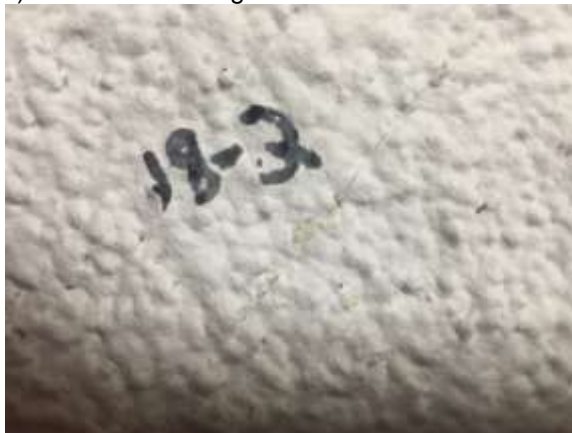
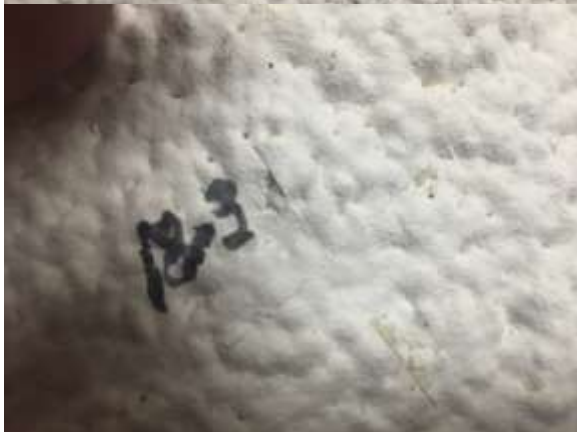
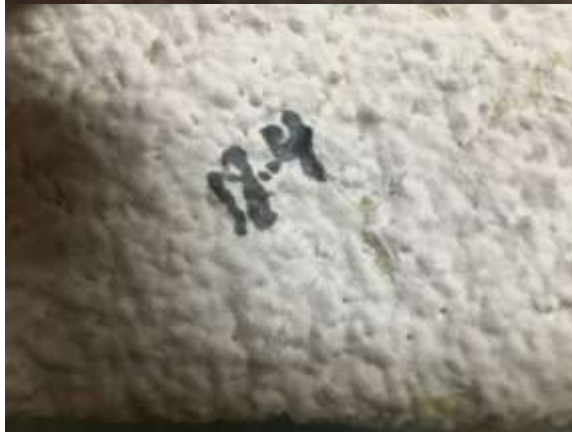
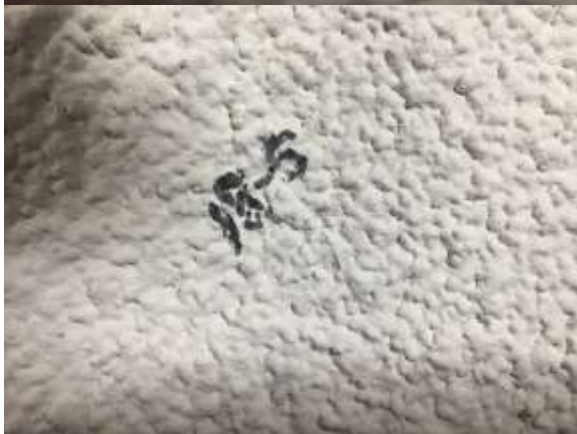
SWD Quick-Shield 112 F spray applied foam and 18 mil (wft) of DC315 Coating

Conditioning: The coating film, applied and dried 'as specified' and then subjected for 7 days to the environmental conditions of 35°C and 92% relative humidity.

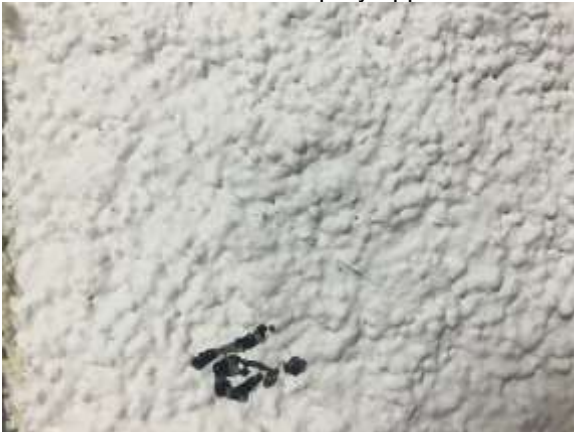
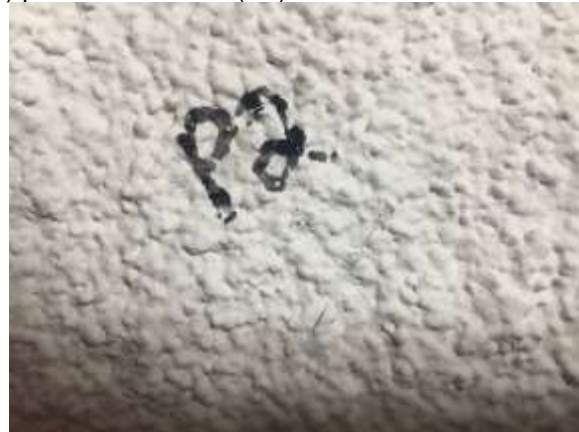
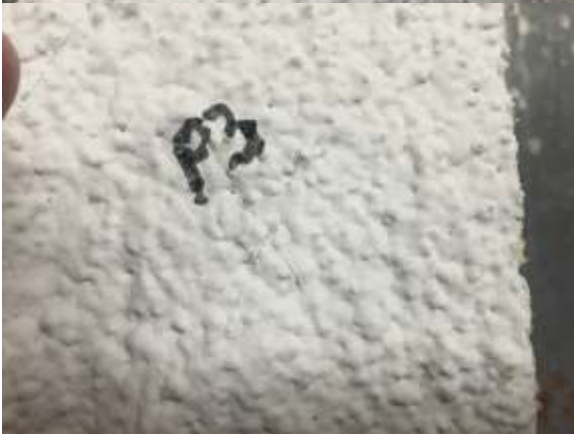
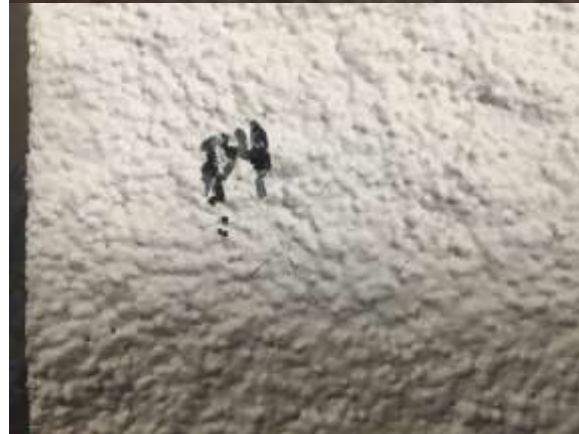
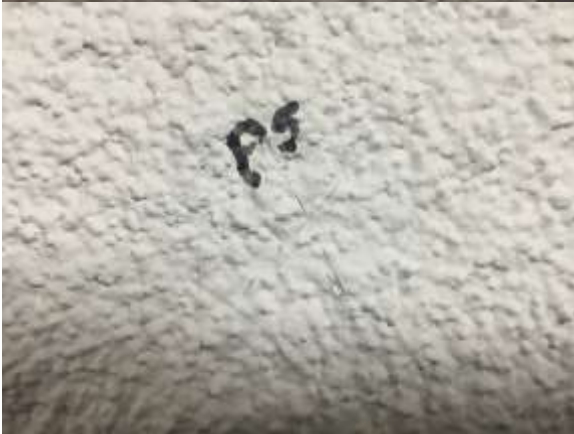
SWD Quick-Shield 112 F spray applied foam and 3 mil (wft) primer and 24 mil (wft) of DC315.
